SUBJ: RCRA Compliance Evaluation Inspection  
Remington Outdoor Company  
EPA ID Number: ALD981932882

## **RCRA Inspection Report**

Remington Outdoor Company  
1816 Remington Circle SW  
Huntsville, Alabama 35824  
Madison County  
EPA ID: ALD981932882

**COMPLIANCE EVALUATION INSPECTION PHOTOGRAPHS**

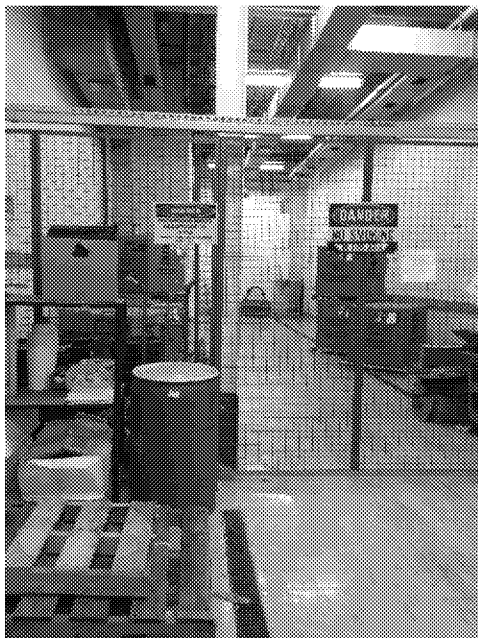
Picture [ SEQ Picture \\* ARABIC ] – HWSA gate

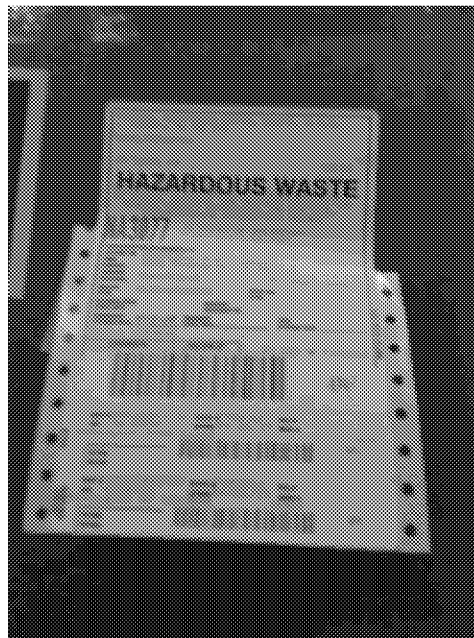
Picture [ SEQ Picture \\* ARABIC ] – HWSA waste pending analysis

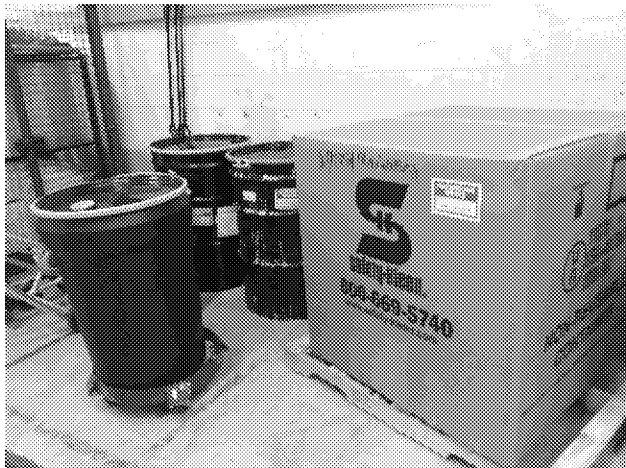
Picture [ SEQ Picture \\* ARABIC ] – HWSA waste pending analysis

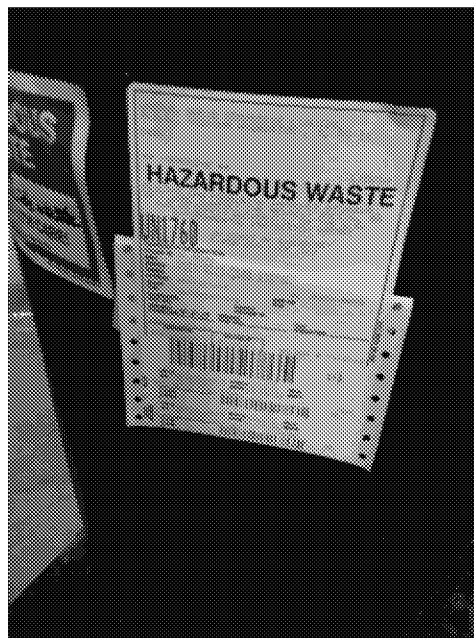
Picture [ SEQ Picture \\* ARABIC ] – HWSA waste pending analysis label

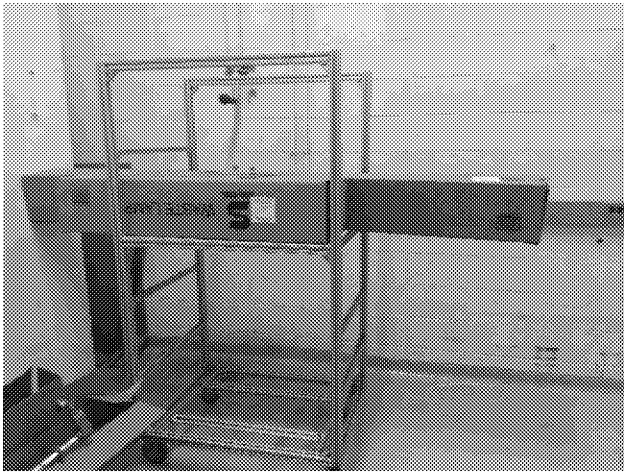
Picture [ SEQ Picture \\* ARABIC ] – HWSA UW lamps

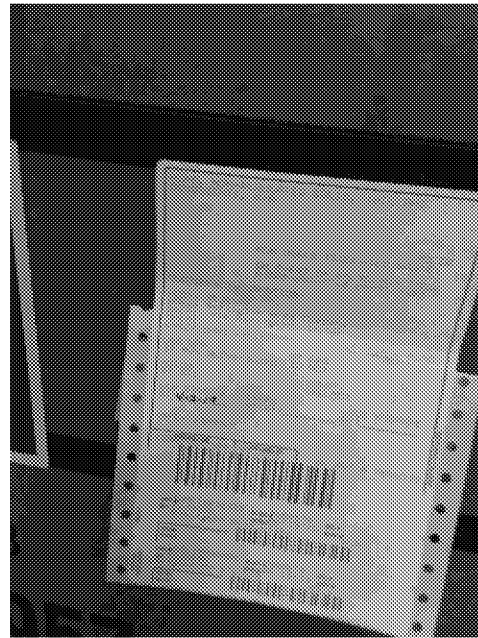
Picture [ SEQ Picture \\* ARABIC ] – HWSA label

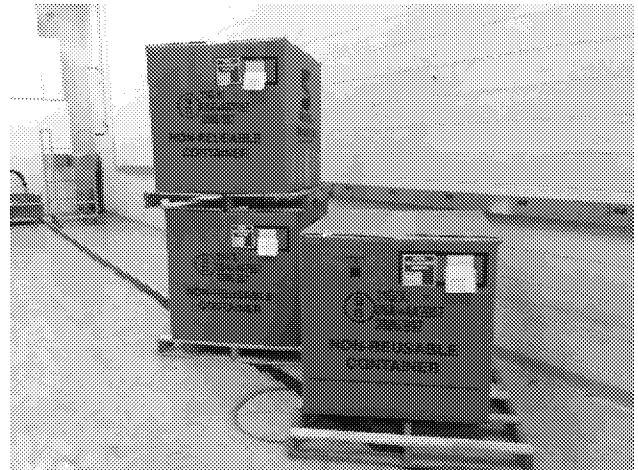
Picture [ SEQ Picture \\* ARABIC ] – HWSA non-HW waste

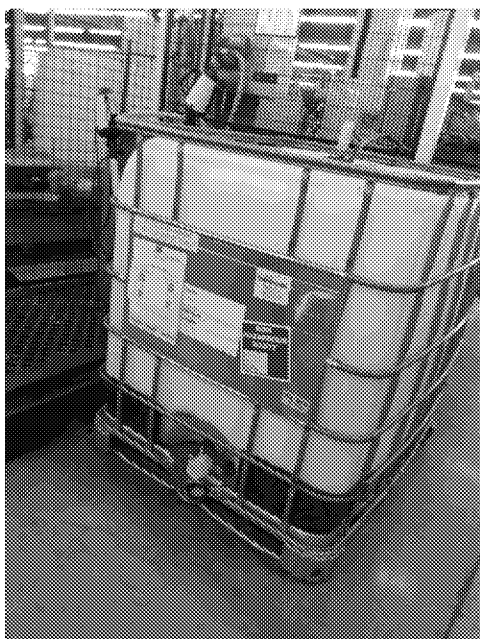
Picture [ SEQ Picture \\* ARABIC ] – Turning Chamber oily water tote

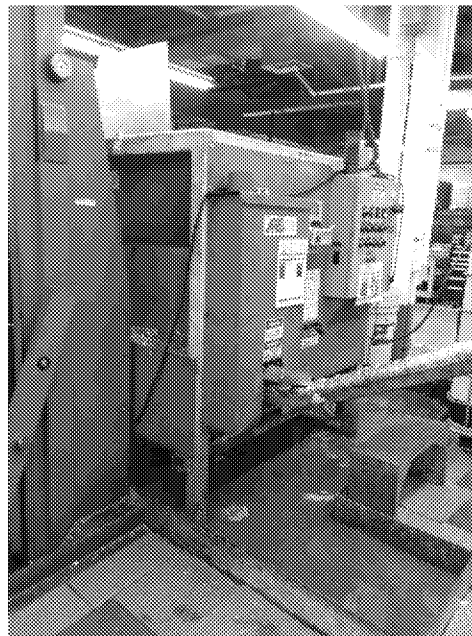
Picture [ SEQ Picture \\* ARABIC ] – Pucker Machine

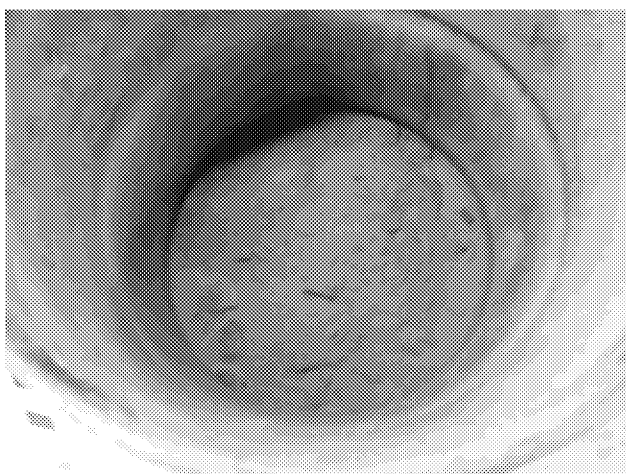
Picture [ SEQ Picture \\* ARABIC ] – Turning Chamber wet blast media

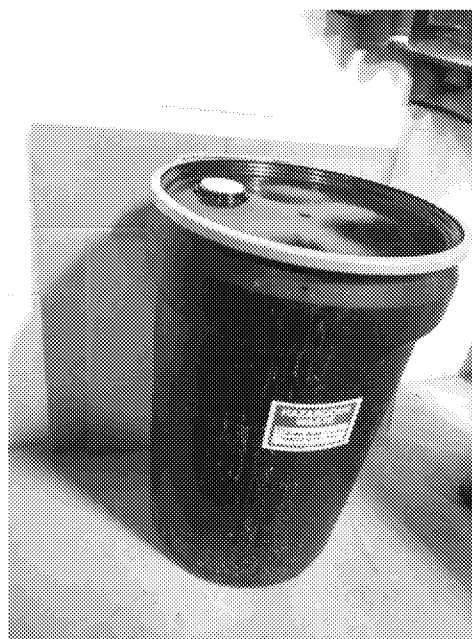
Picture [ SEQ Picture \\* ARABIC ] – Black Oxide Area SAA drum

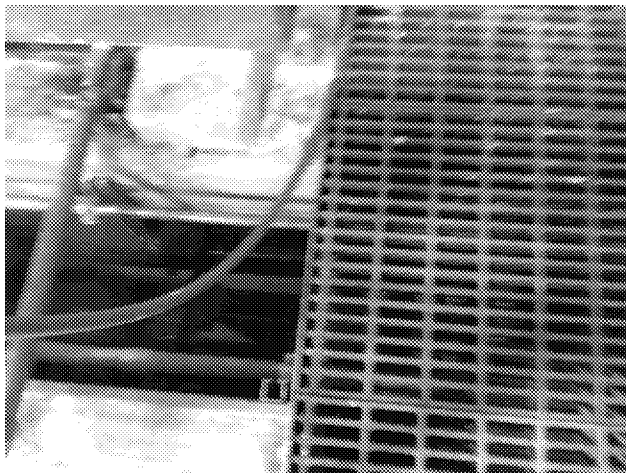
Picture [ SEQ Picture \\* ARABIC ] – Black Oxide Area floor grate

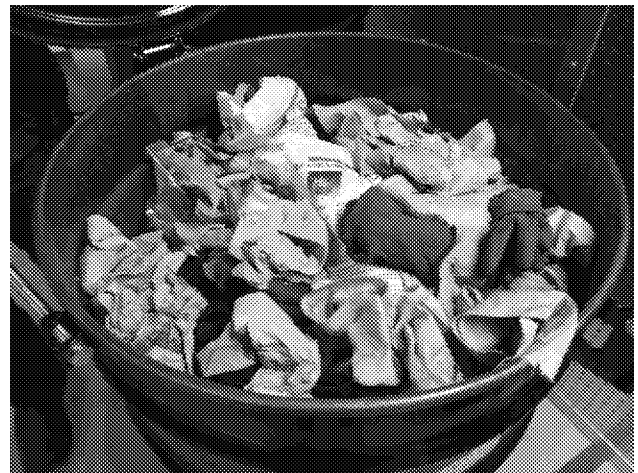
Picture [ SEQ Picture \\* ARABIC ] –25-Yard Range lead contaminated PPE drum

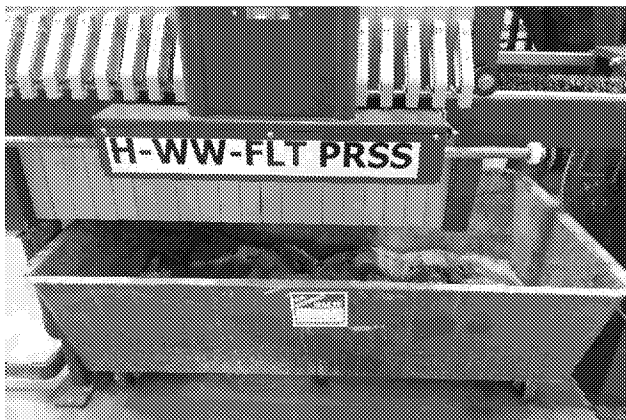
Picture [ SEQ Picture \\* ARABIC ] – WWTP filter sludge press

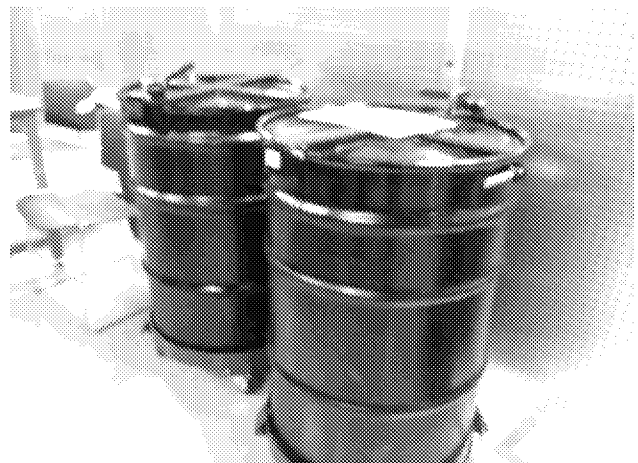
Picture [ SEQ Picture \\* ARABIC ] – 200 Meter Range lead contaminated PPE drum

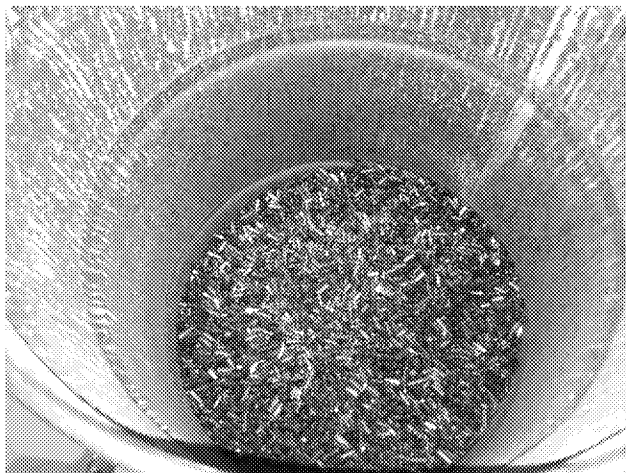
Picture [ SEQ Picture \\* ARABIC ] – 25-Yard Range brass casing drum

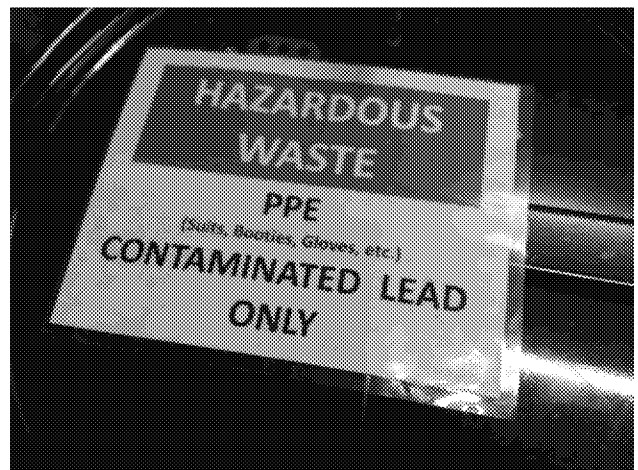
Picture [ SEQ Picture \\* ARABIC ] –200 Meter Range lead contaminated PPE label

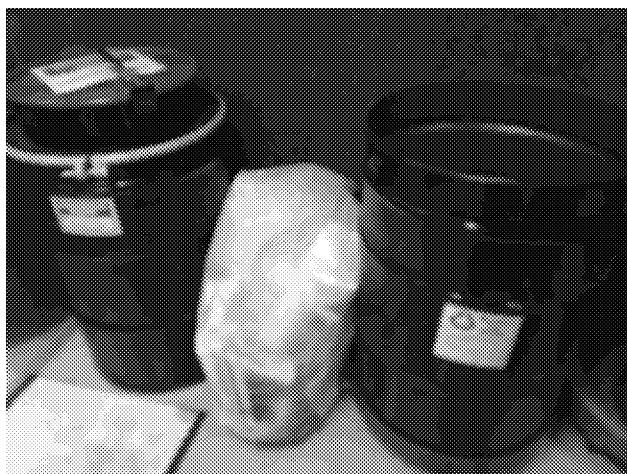
Picture [ SEQ Picture \\* ARABIC ] – Proofing Range lead contaminated PPE drum

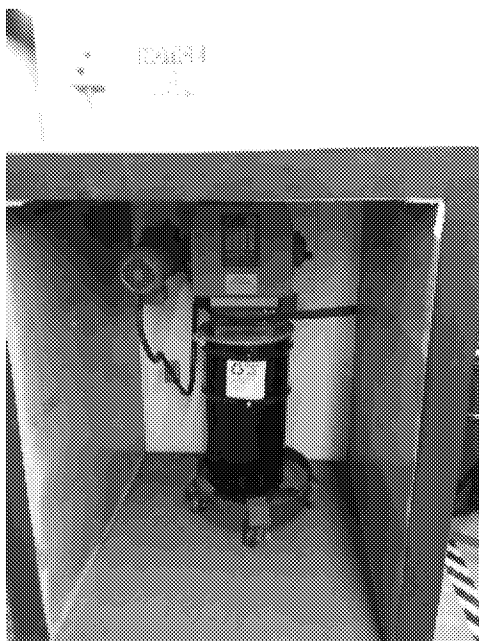
Picture [ SEQ Picture \\* ARABIC ] –100 Meter Range conveyor box debris drum

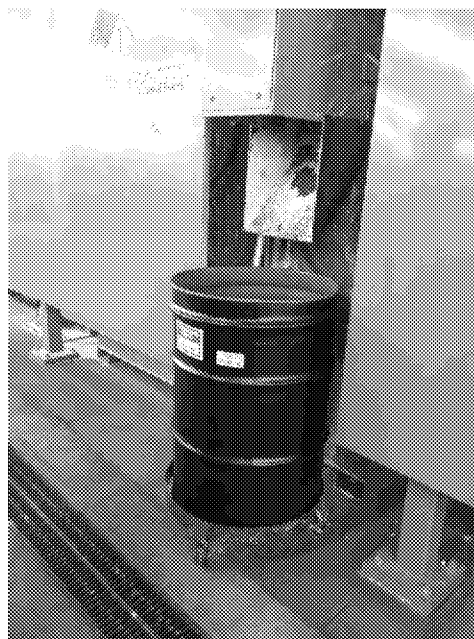
The salt bath furnace quickly hardens the steel by heat treating the metal with a salt quench. The inspectors observed Gaylord boxes of oily pig mats and coat filters and a 55-gallon SAA drum sitting under a chute (Picture 24). The SAA drum was labeled and open and contained hazardous waste salt bath residue. The waste residue was spraying on the floor and into the grate under the drum. The inspectors explained that the drum was required to be closed to prevent the release of the hazardous salt bath residue from releasing on the ground.

**Pursuant to ADEM Admin. Code r. 335-14-3-.01(5)(a)4. [40 C.F.R. § 262.15(a)(4)], which is a condition of the SAA Permit Exemption, a generator is required to keep containers of hazardous waste closed at all times during accumulation, except when adding, removing, or consolidating waste; or when temporary venting of a container is necessary for the proper operation of equipment, or to prevent dangerous situations, such as build-up of extreme pressure.**

Picture [ SEQ Picture \\* ARABIC ] – Salt Bath Furnace SAA releasing residue on floor

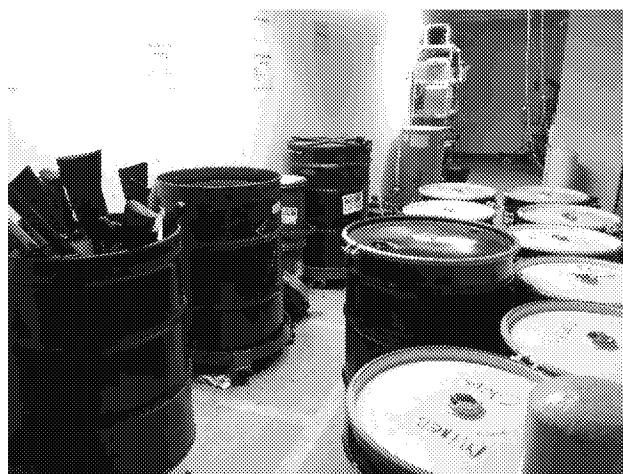
Picture [ SEQ Picture \\* ARABIC ] – R&D HWSA
